2017 PEDESTRIAN ACCESSIBILITY STUDY

Natick, Massachusetts

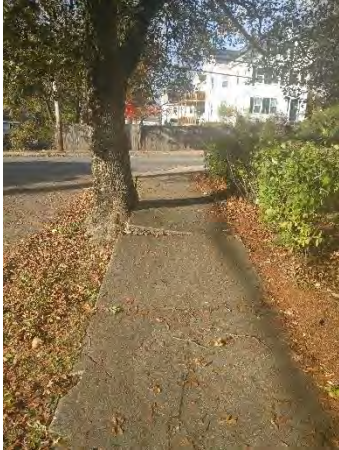
Example of trip hazard on Pitts St.

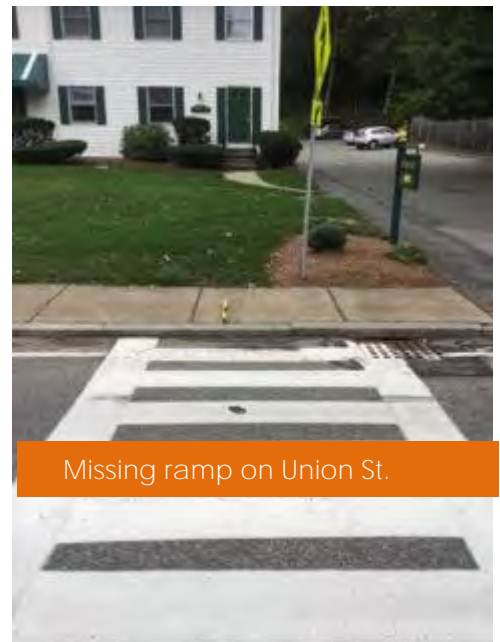
Missing ramp on Union St.

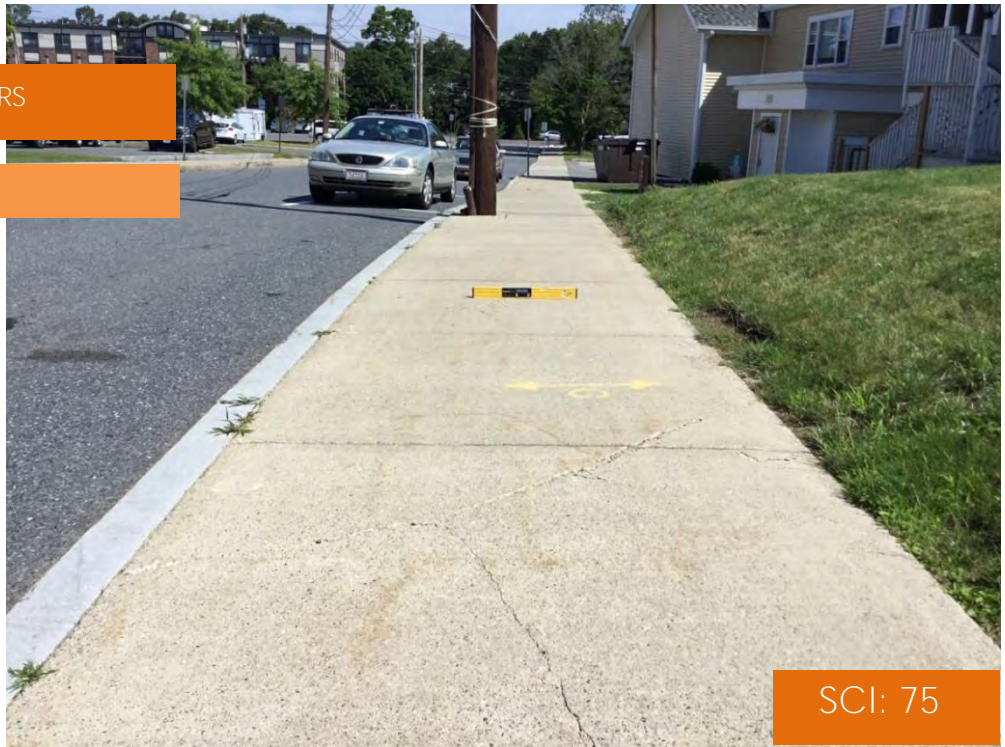
Hayes Street

LOCALIZED REPAIRS

SCI: 75

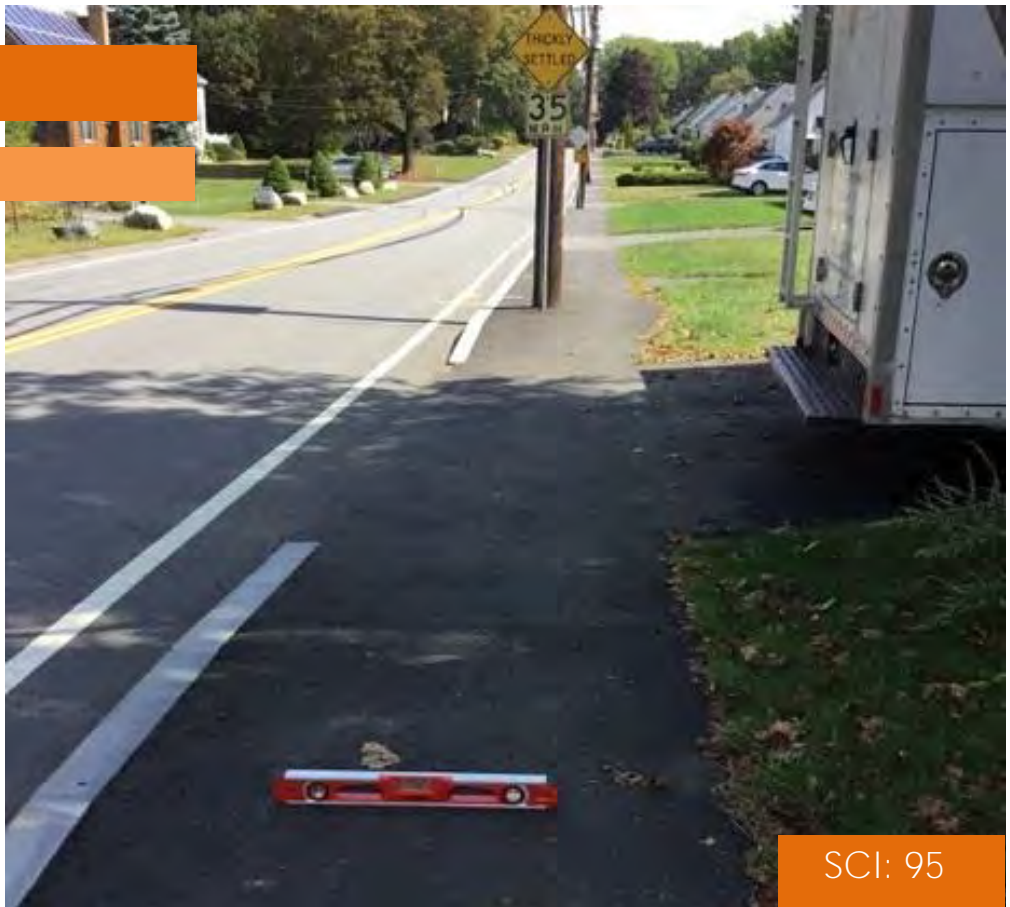
Pine Street

DO NOTHING

SCI: 95

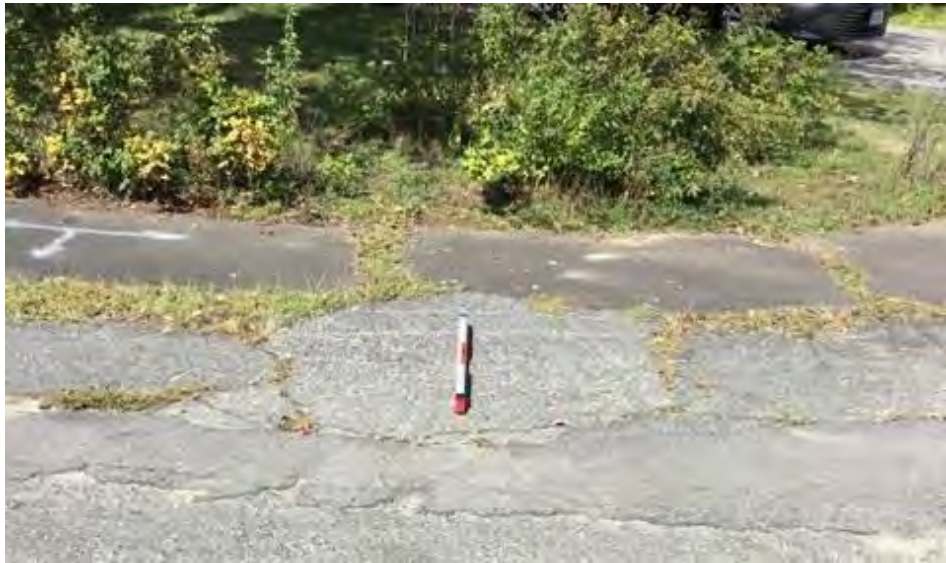
Liberty Street

The distribution of apron slopes Town-wide are relatively good as they normalize around the acceptable MAAB slope of 8.3%. However, there are a significant number of ramps which have apron slopes exceeding 16% which is worrisome. A majority of these ramps come in neighborhoods with bituminous sidewalks with minimal efforts made towards creating accessible ramps. A few examples of these are shown below.

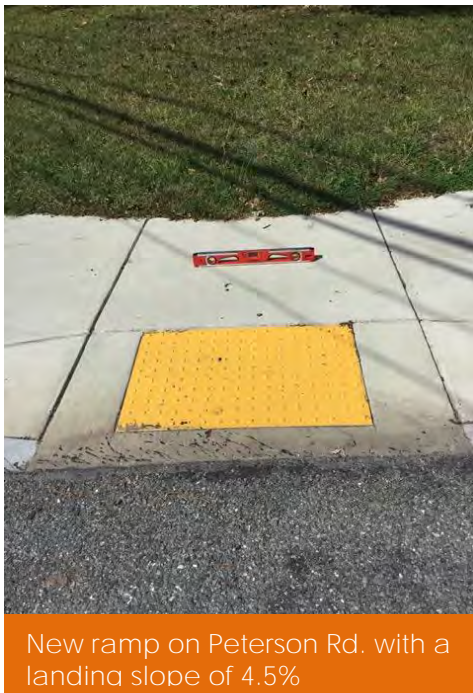
New ramp on Peterson Rd. with a landing slope of 4.5%

Given the current condition of the network, it is likely that Natick has been funding the needs of the sidewalk and ramp network throughout the years. Based on the analysis from this study, a baseline of \$1.25M should be spent to maintain current conditions. Stantec observed some ‘newly constructed’ ramps in the field which were minimally non-compliant due to workmanship which can be improved with better field layout and inspection. By putting a little more effort to build it right the first time, the Town can get more benefit from its asset investment of the network. The image to the left shows a new ramp built on Peterson Road which failed the landing slope compliance

by 2.5%.

1. Implement a sound departmental quality control/assurance program, with particular focus on MAAB construction standards. Offer incentive/disincentive(s) based on new, in-placed ramp construction.
