2017 PEDESTRIAN ACCESSIBILITY STUDY

Natick, Massachusetts

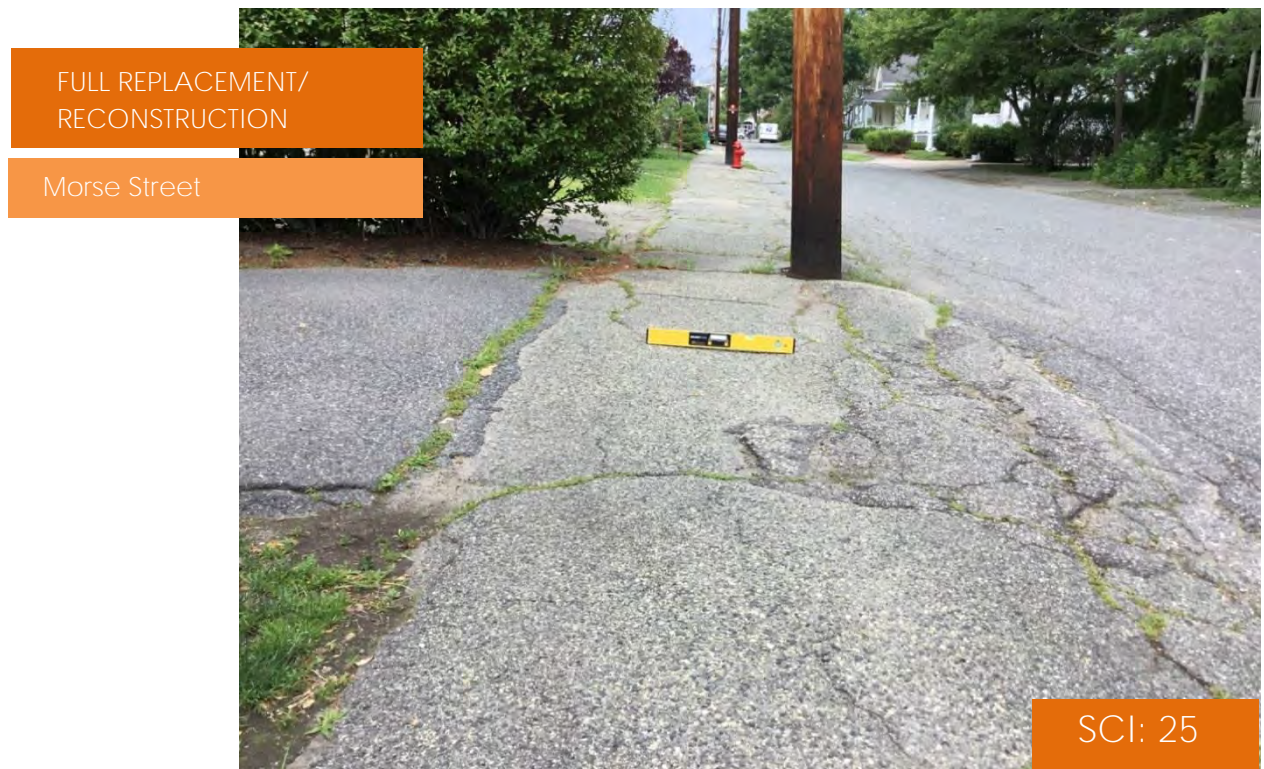
- 0-49 = Full Replacement/ Reconstruction
- 50-79 = Localized Repairs/ Panel Replacement
- 80-100 = Do Nothing

The figures below show the visual difference between the three categories:

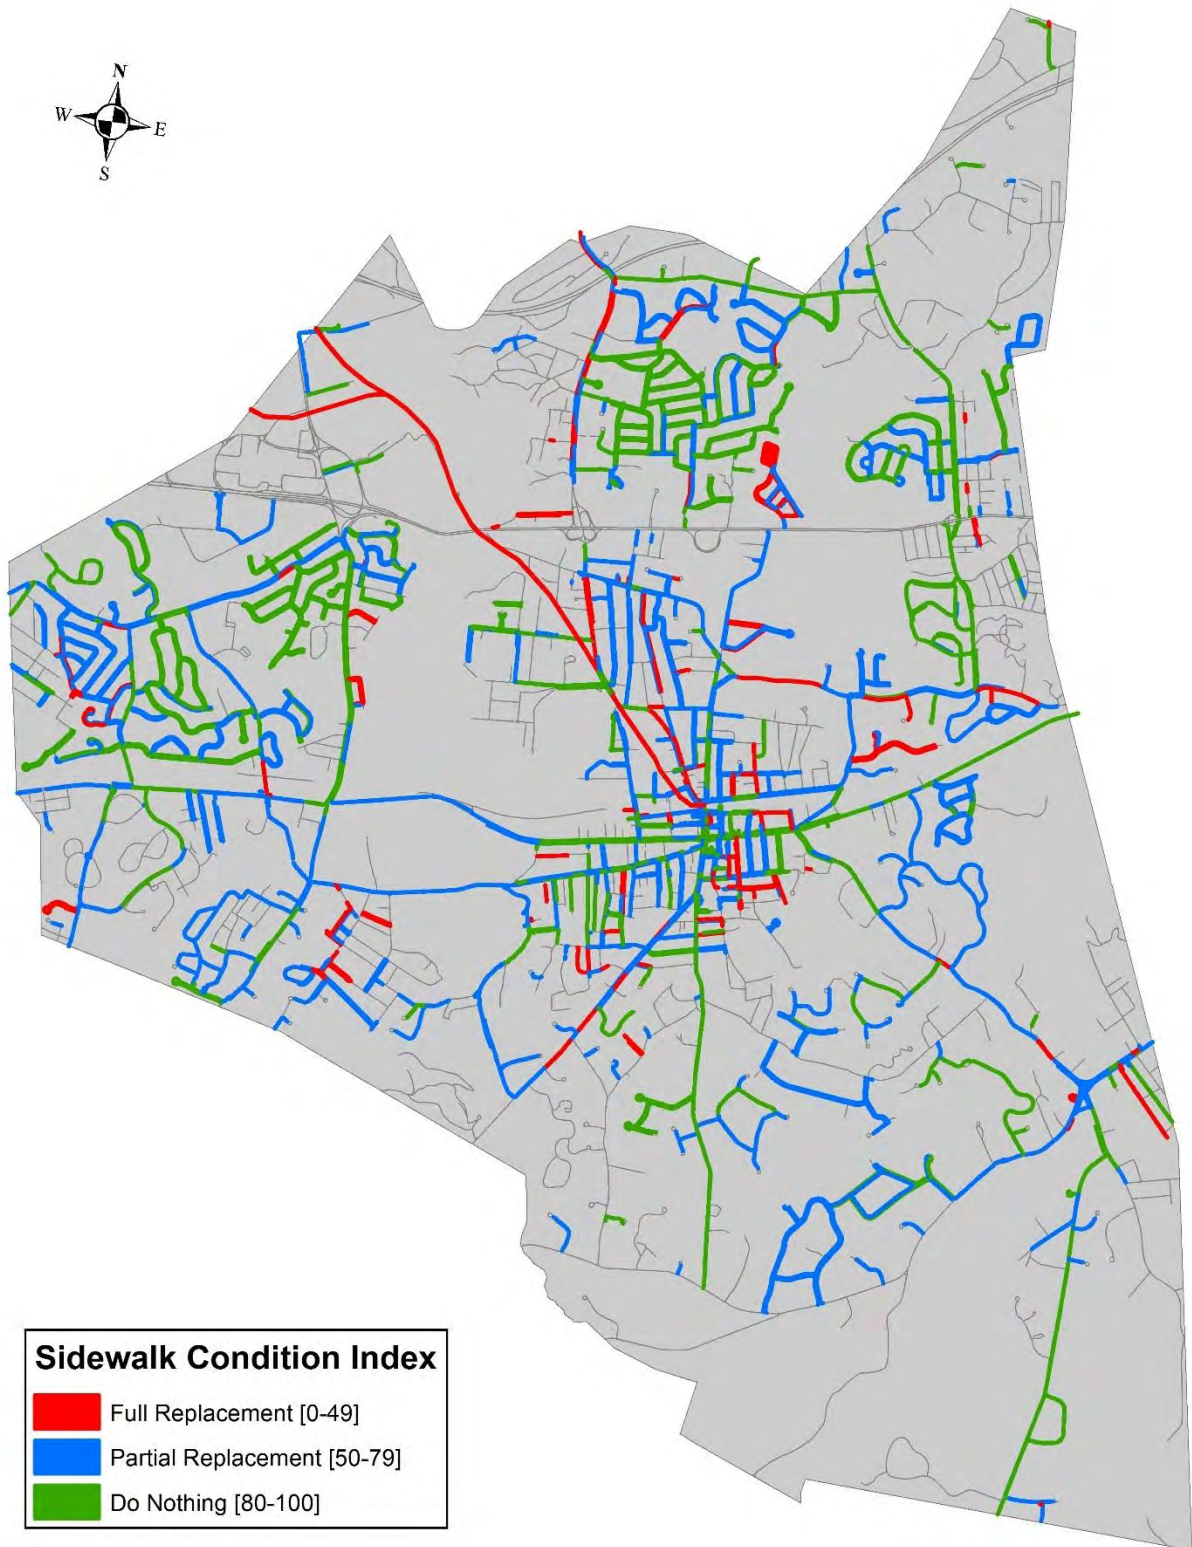
Figure 2
SCI of Sidewalk Network

The average area based SCI in Natick is 70, which puts average conditions at the border of fair/good. With 39% of the sidewalk network in the 'Do Nothing' treatment band and 48% in the 'Localized Repair' treatment band, the Town of Natick is in relatively good shape. Figure 2 below shows the distribution of the different SCI treatment bands throughout the Town.

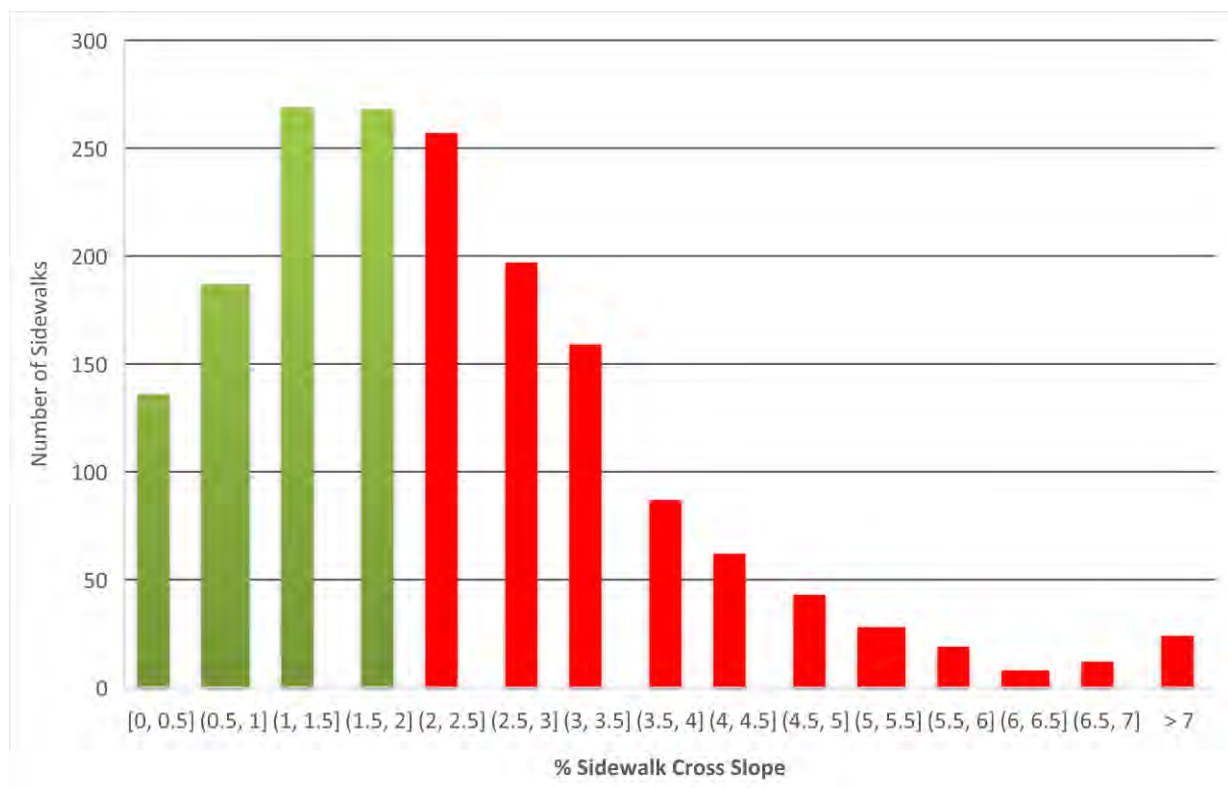
Figure 3 Distribution of Sidewalk Cross-Slope

The notes field was also evaluated to determine if street furniture, buildings, or other hardscape obstructions prevented passage along the sidewalk. Figures 3 displays the cross-slope measurements where green bars represent likely compliant slopes, and red bars represent likely non-compliant slopes. It can be seen from these that the primary reason for likely non-compliance in Natick is the sidewalk cross-slope since the majority of sidewalk widths surpass the 3 foot threshold.

For this report, a sidewalk was considered likely compliant if the cross slope was less than 2%, width greater than 3 feet, and an SCI greater than 85. Within those thresholds, it was determined that only 21% of sidewalks in Natick are likely compliant.

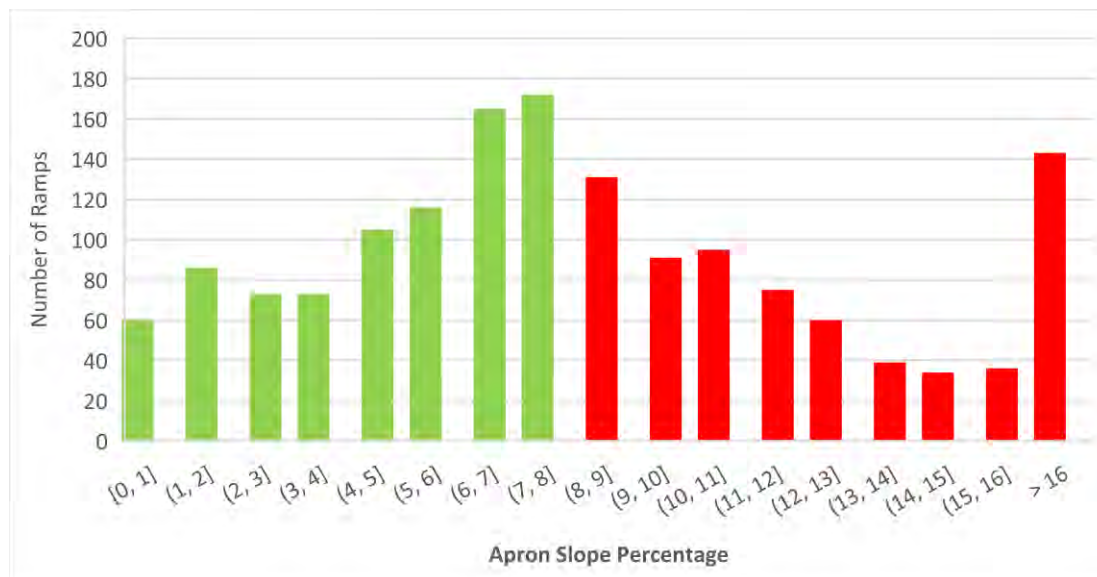
Figure 5
Distribution of Ramp Slope Percentage

The distribution of apron slopes Town-wide are relatively good as they normalize around the acceptable MAAB slope of 8.3%. However, there are a significant number of ramps which have apron slopes exceeding 16% which is worrisome. A majority of these ramps come in neighborhoods with bituminous sidewalks with minimal efforts made towards creating accessible ramps. A few examples of these are shown below.

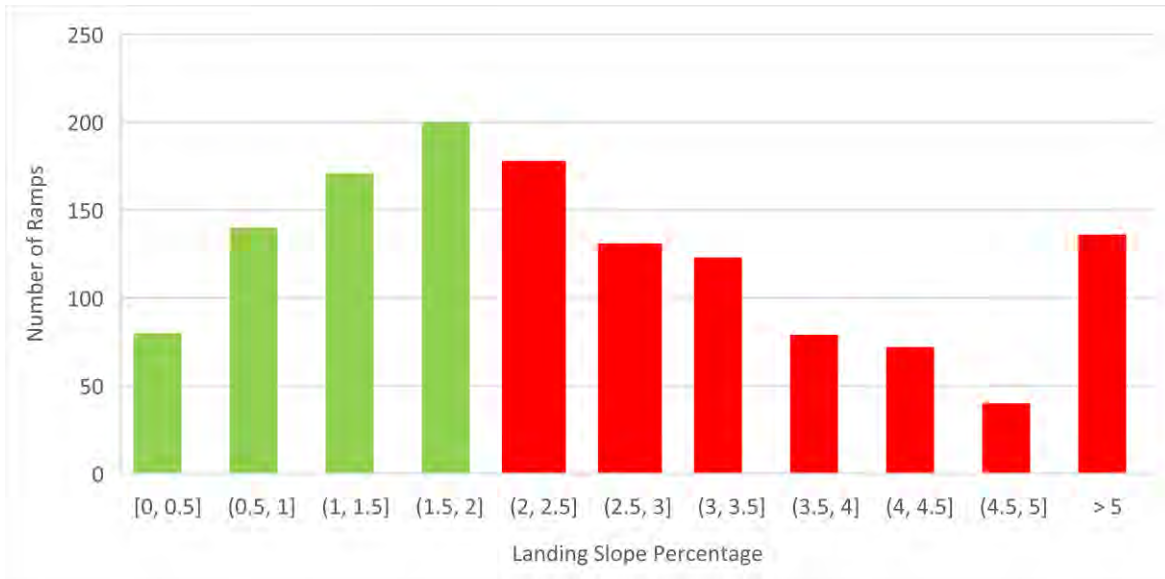
Figure 6
Distribution of Landing Slope Percentage

Note: Figure 6 excludes ramps in which no level landing was present

In determining likelihood of MAAB compliance, five primary attributes were used: visual inspection, ramp slope, landing slope, crosswalk deficiencies, and presence of a lip. In using these, it was determined that 74% of the existing ramps in Natick (excluding missing ramps) are likely not compliant with MAAB standards.

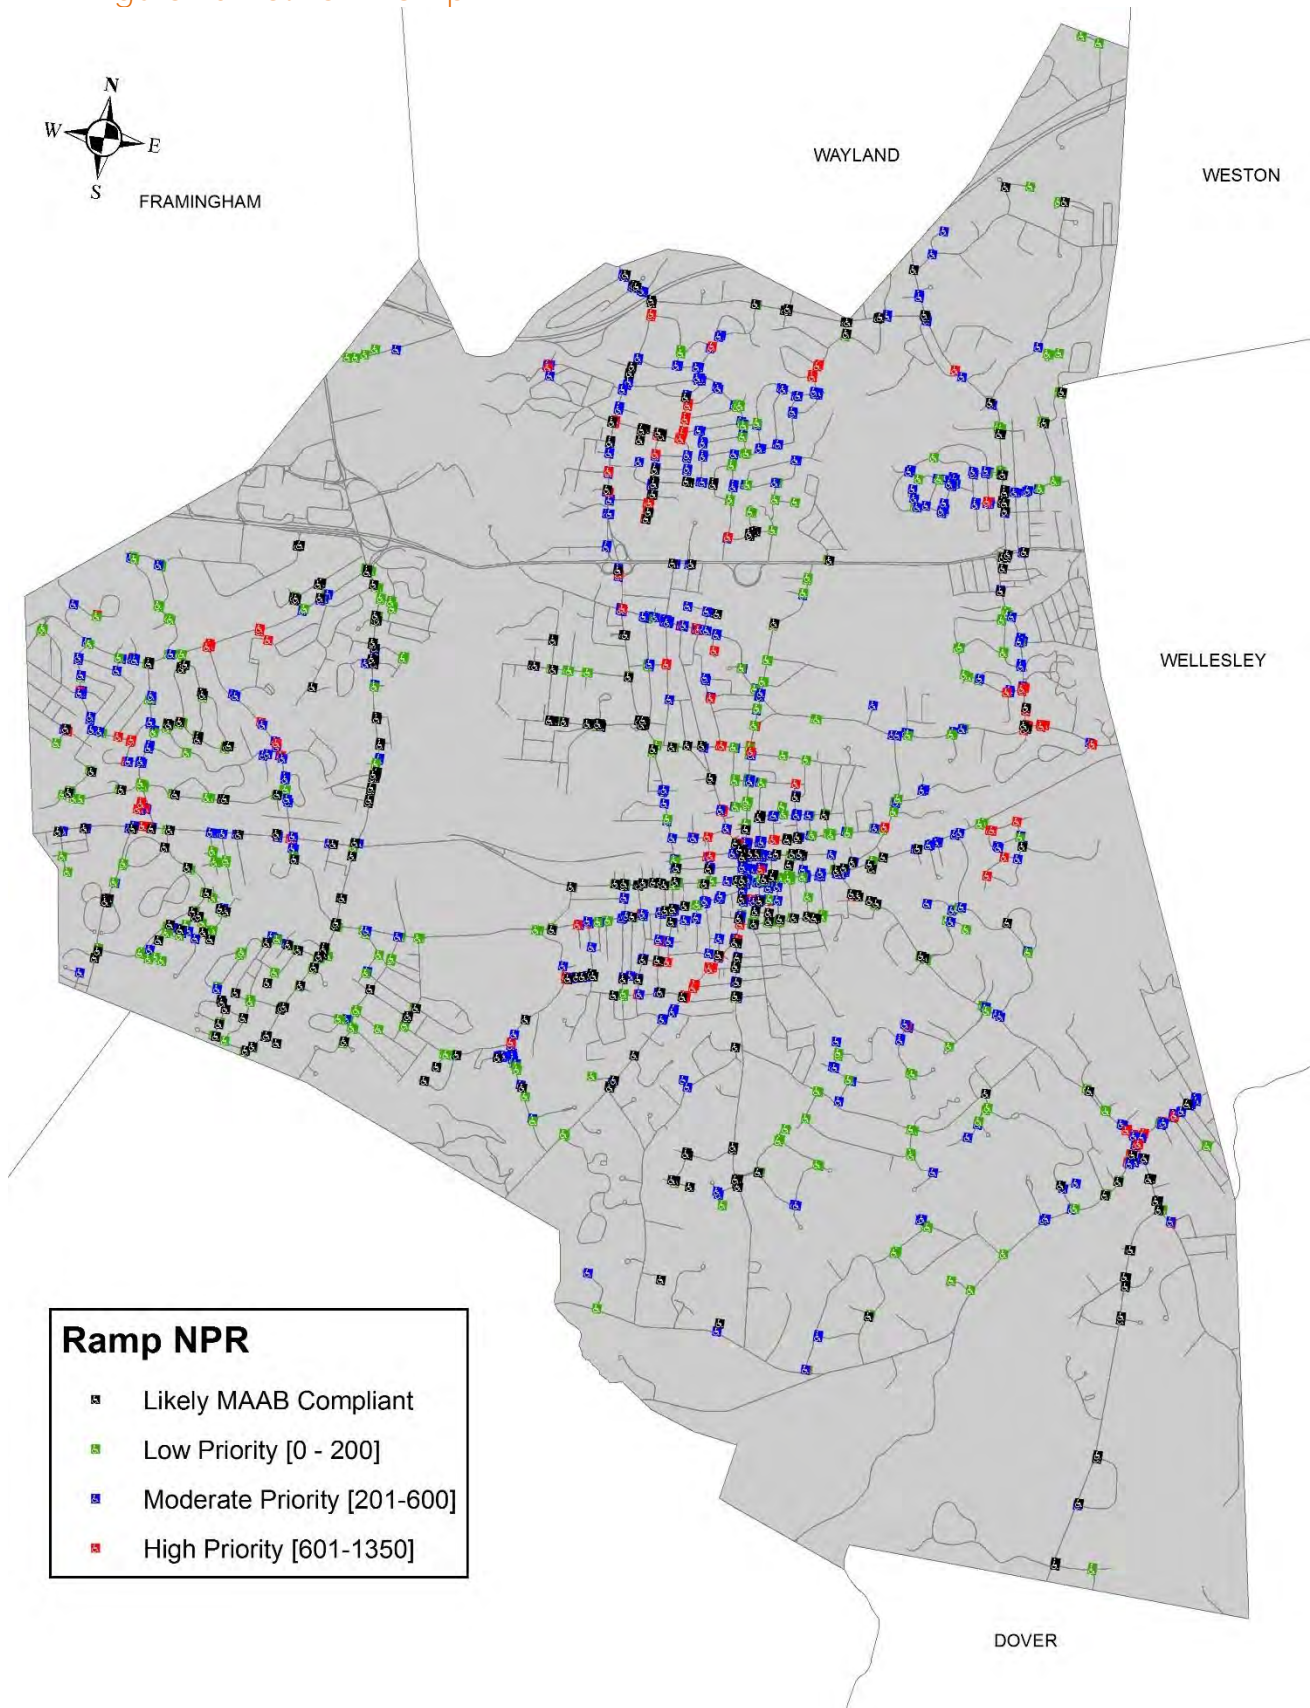
Figure 10 Network Ramp NPR

Once the final NPR values were summed for ramps, they were distributed into three categories based on the distribution of the values. Figure 10 shows all the likely-compliant ramps, as well as the priority levels on all non-compliant ramps.

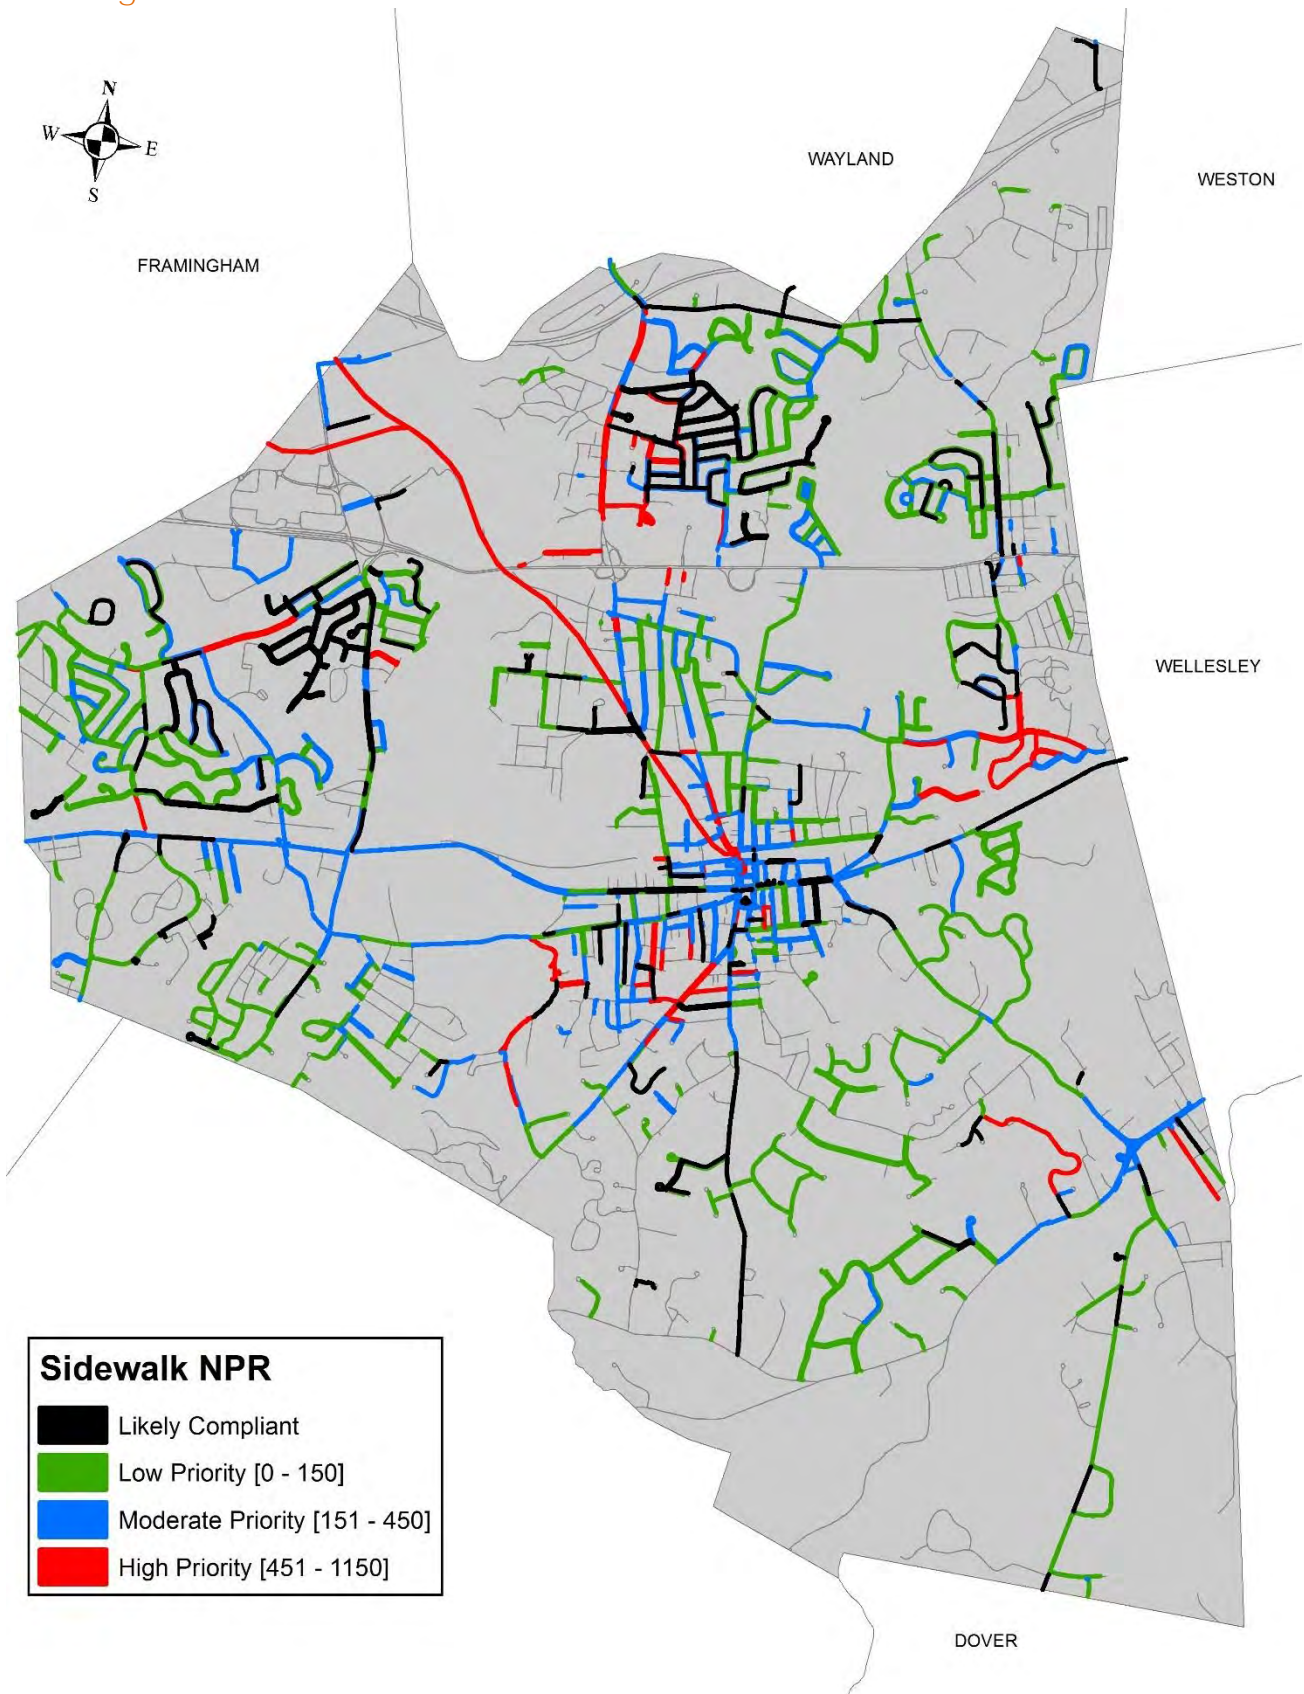
Figure 11 Network Sidewalk NPR

Once the final NPR values were summed for sidewalks, they were distributed into three categories based on geometric split. Figure 11 shows the NPR values for sidewalks throughout the Town. Sidewalks with a cross slope less than 2%, width greater than 4 feet, and SCI greater than 85 were considered compliant below and received an NPR value of 0.
